A summary of a NIOSH fire fighter fatality investigation

A Career Captain and an Engineer Die While Conducting a Primary Search at a Residential Structure Fire – California

Fatality Assessment and Control Evaluation Investigation Report # F2007-28

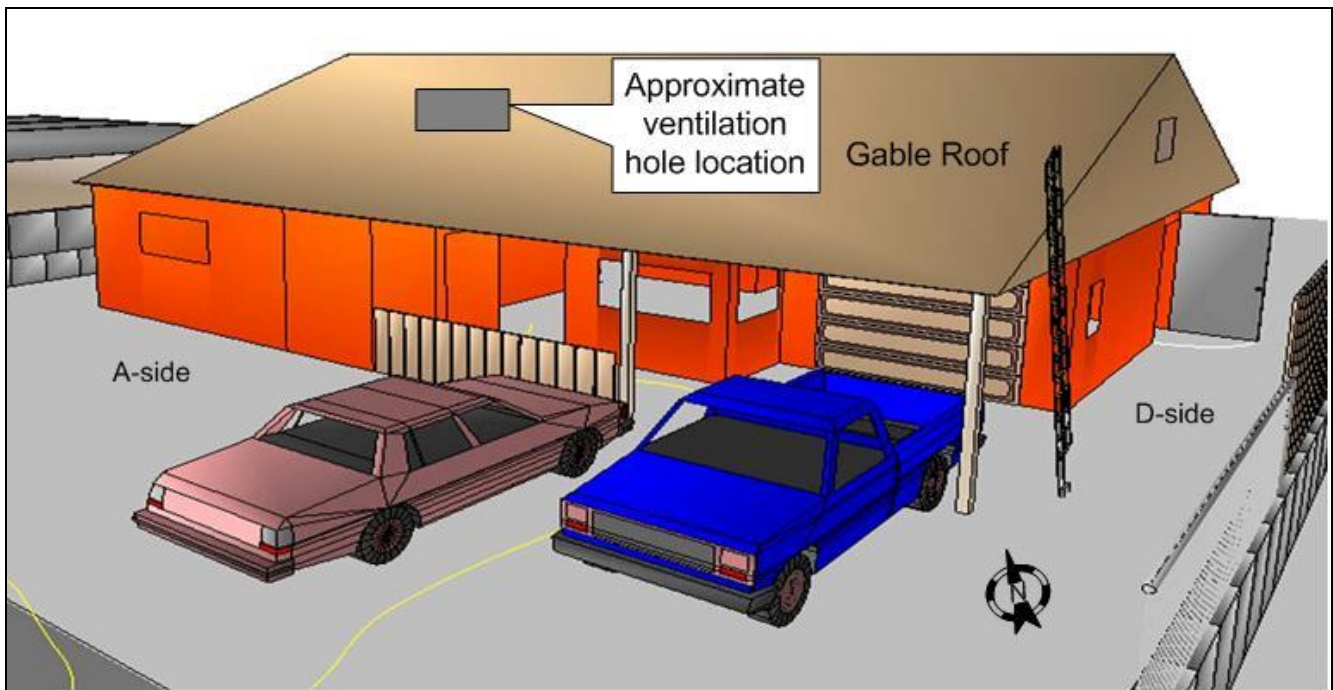
The crew from E69 laddered the D-side towards the front of the structure and then heard that the first civilian was found and was being removed from the structure (Figure 1). The E69 crew immediately went to the front porch to assist with removing the civilian to the front lawn area. *Note: The gas powered PPV fan was running facing the front door. The E69 officer noticed that the smoke conditions in the living room area were negligible at this time.*

Figure 1. Ladder location on D-Side of structure.

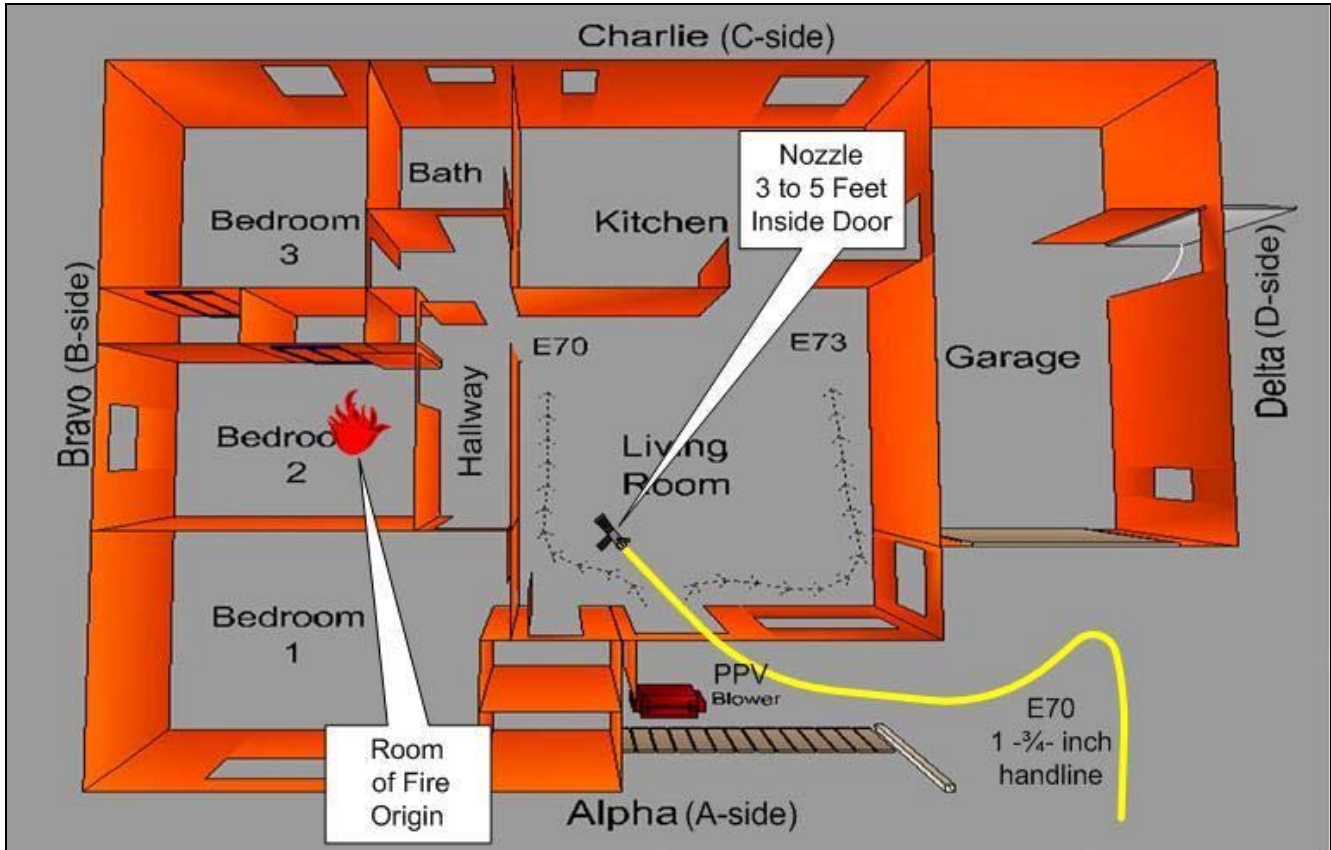
to confirm his request with Engine 69 (E69) while they were responding. The fire fighter from E73 went to retrieve the TIC. The E70 engineer told him that he would get it and directed him to help with hooking-up the hydrant. After assisting with the hydrant, the E73 fire fighter returned to make entry. The officer from E73 requested a positive pressure ventilation (PPV) fan from Engineer 70 because visibility was zero. The two victims were standing as they made entry through the smoke and proceeded to the left. The crew from E73 went to the right to search for the victims. The conditions were hot and visibility was near zero. (Figure 2).

In this incident, positive pressure was applied at the door on Side-A with the only exhaust opening being the large window in the living room which had broken out prior to the arrival of the first company. This potentially placed the search teams between the fire (in the bedrooms and hallway) and the exhaust opening (in the living room). In addition, no fire control action was being taken during the search as the hoseline deployed by E70 was unstaffed. Application of positive pressure without an adequate opening (in this case the opening may have been marginally adequate, but in a non optimal location) results in increased air supply to the fire, turbulence, and mixing of hot smoke (fuel) and air which can result in a fire gas ignition or ventilation induced flashover. It is not recommended to initiate positive pressure ventilation after firefighters enter the building⁸. If used post fire control, fire fighters should be withdrawn to a safe (uninvolved) area or out of the building while it is pressurized. If used in positive pressure attack, the building should be pressurized and the effectiveness of ventilation verified by observation prior to entry⁸.

Figure 2. Location of E70 nozzle, positive pressure ventilation, and search patterns of E70 and E73.

Recommendation #4: Ensure that firefighters understand the influence of positive pressure ventilation on fire behavior and can effectively apply ventilation tactics.

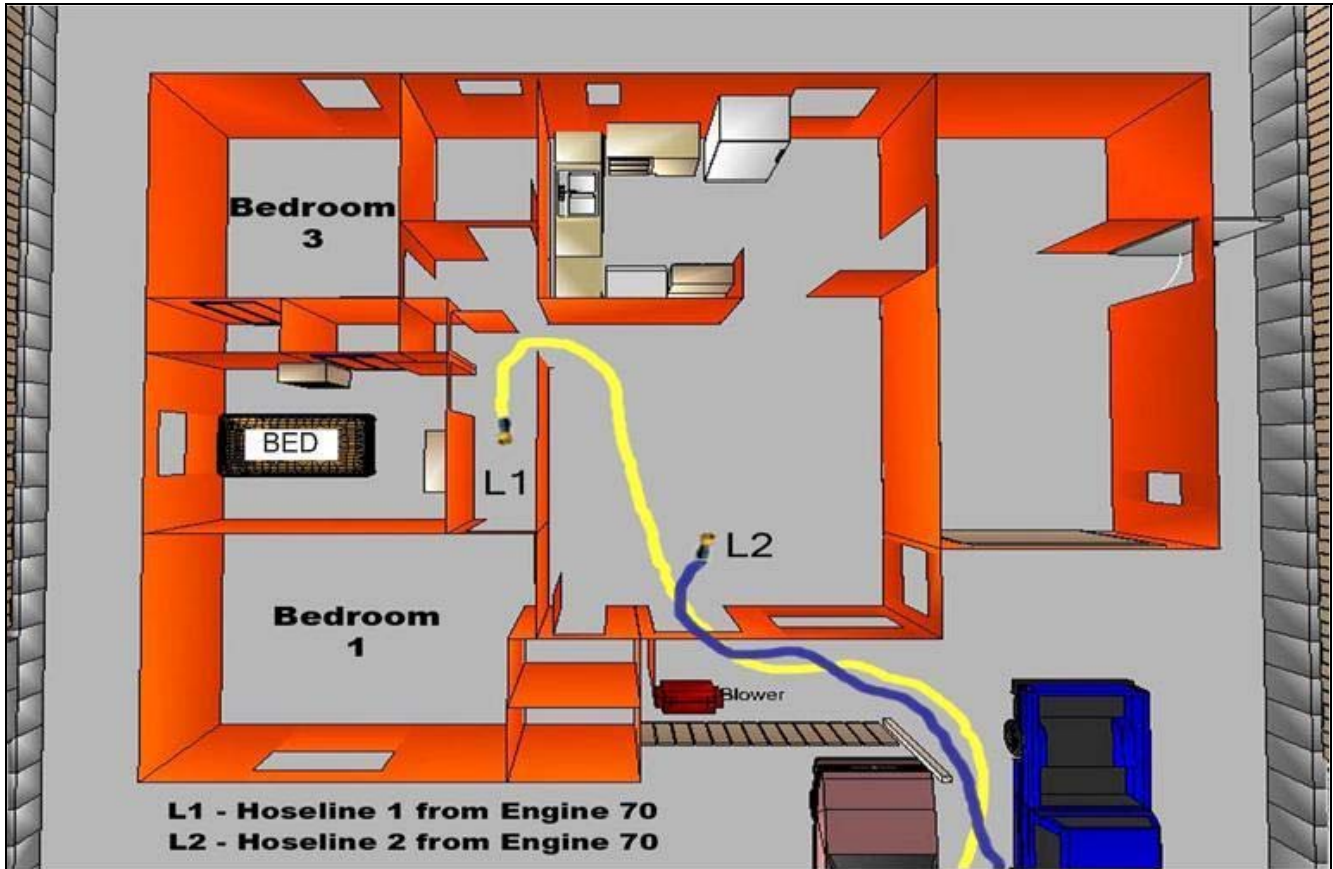
The Q76 officer was backing up his fire fighter on the nozzle as they fought fire around the corner and into the hallway leading into the bedrooms (Figure 3). They darkened down the fire in the middle bedroom and the captain scanned the area with his TIC and did not pick up anything on the screen. *Note: The crew from Q76 did not know that the victims were missing at this point. The crew did not hear any PASS devices.*

Figure 3. Hoseline locations from E70.

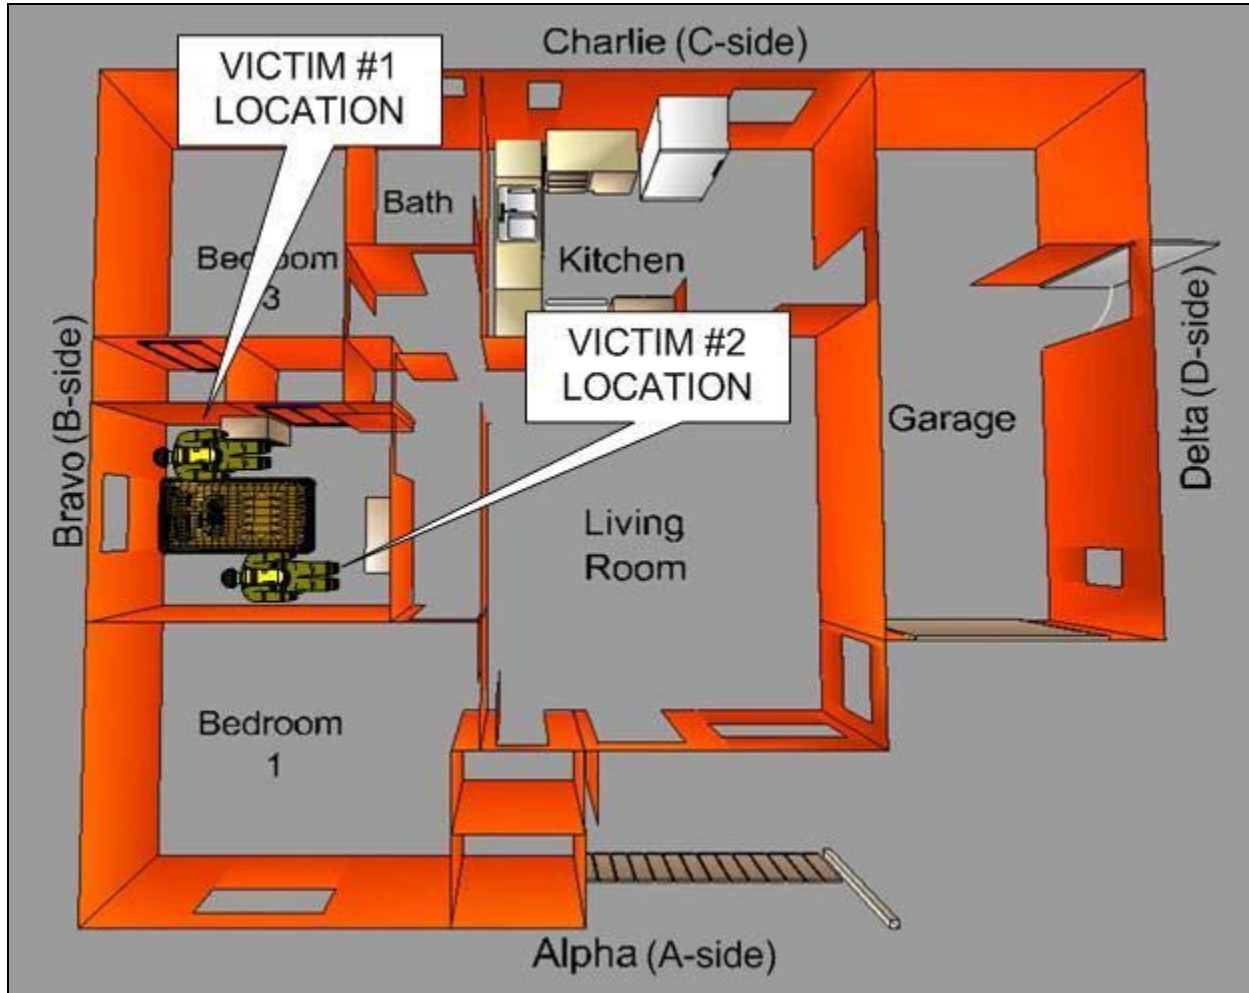
The fire originated in the Bedroom 2 (see Figure 2) where the two victims were found. It is believed to have started from improper disposal of smoking materials by the owners.

The E69 crew re-entered with a handline, but did not have a TIC with them. They proceeded into the hallway and bedroom areas and extinguished spot fires as they searched for the missing fire fighters and listened for any PASS devices. *Note: It is probable that the PASS devices did not function properly due to the heat and fire impingement.* The smoke was banked down to around neck level with good visibility below that level. The crew visibly searched the small bedrooms, but did not see the victims. The E69 officer exited to confirm his finding with the IC and to make sure the E70 crew was not outside. He went back inside and met-up with his crew in Bedroom #2. The crew was searching when the evacuation horns sounded at approximately 0221 hours. BC7 ordered the evacuation signal to conduct a personnel accountability report (PAR). They began to exit when the E69 engineer noticed Victim #1 in the right rear corner of Bedroom #2. They immediately began to remove Victim #1. FF76 and E68 crew assisted with the removal. BC 64 was on-the-scene at this time and was aware of a fire fighter missing, but not fully aware of the search operations taking place. He entered without proper turnout gear in an attempt to search for the second victim. Victim #2 was located on the left side of Bedroom #2 by the Q76 officer. Additional crews, including an automatic aid crew and BC64 assisted with recovering the victim from the structure at approximately 0228 hours (Figure #4).

Figure 4. Location of victims in Bedroom #2.

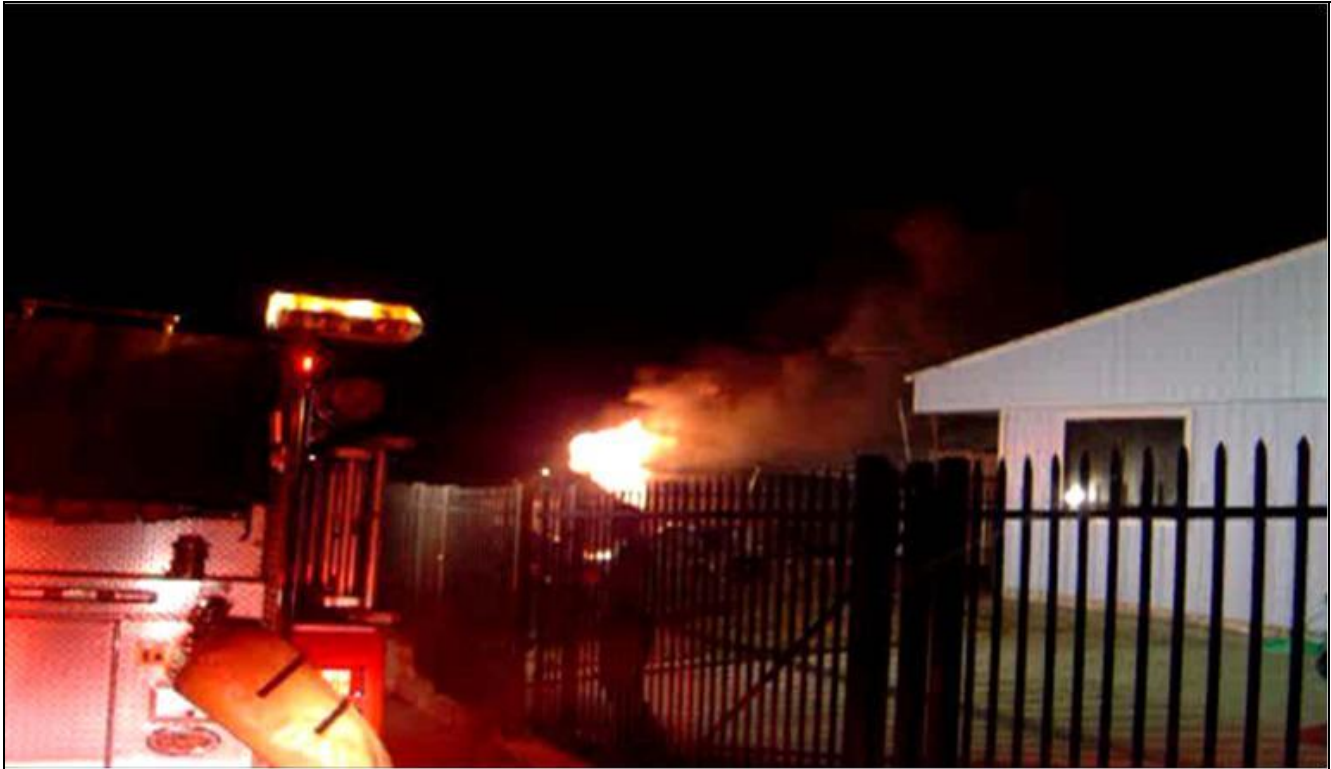
Quint 76 (Q76) arrived on-the-scene at 0159 hours. While the crew was donning their gear, the Q76 fire fighter took a photograph and a short video that showed a rapid fire event venting from the A-side bedroom window (Photo 1). The E73 fire fighter was administering care to the civilian on the front lawn when the rapid fire event occurred and he reported large amounts of fire venting from the front bedroom window for approximately 15 seconds. *Note: Members on the fire ground described the rapid fire progression as a sound resembling a tire exploding, which resulted in heavy flames shooting out from the front bedroom window.*

Photo 1. Flames exiting window on A-Side from rapid fire development.
(Photo courtesy of Fire Department.)
