FAIRFAX COUNTY FIRE & RESCUE DEPARTMENT POST INCIDENT ANALYSIS		
	NUMBER: 2007-002	DATE: August 1, 2007	DISTRIBUTION: I
	ISSUED BY: Deputy Chief John A. Burke and the Appointed Committee Special Operations Division		
	INCIDENT: Townhouse Fire 9207 Cardinal Forest Lane May 23, 2007

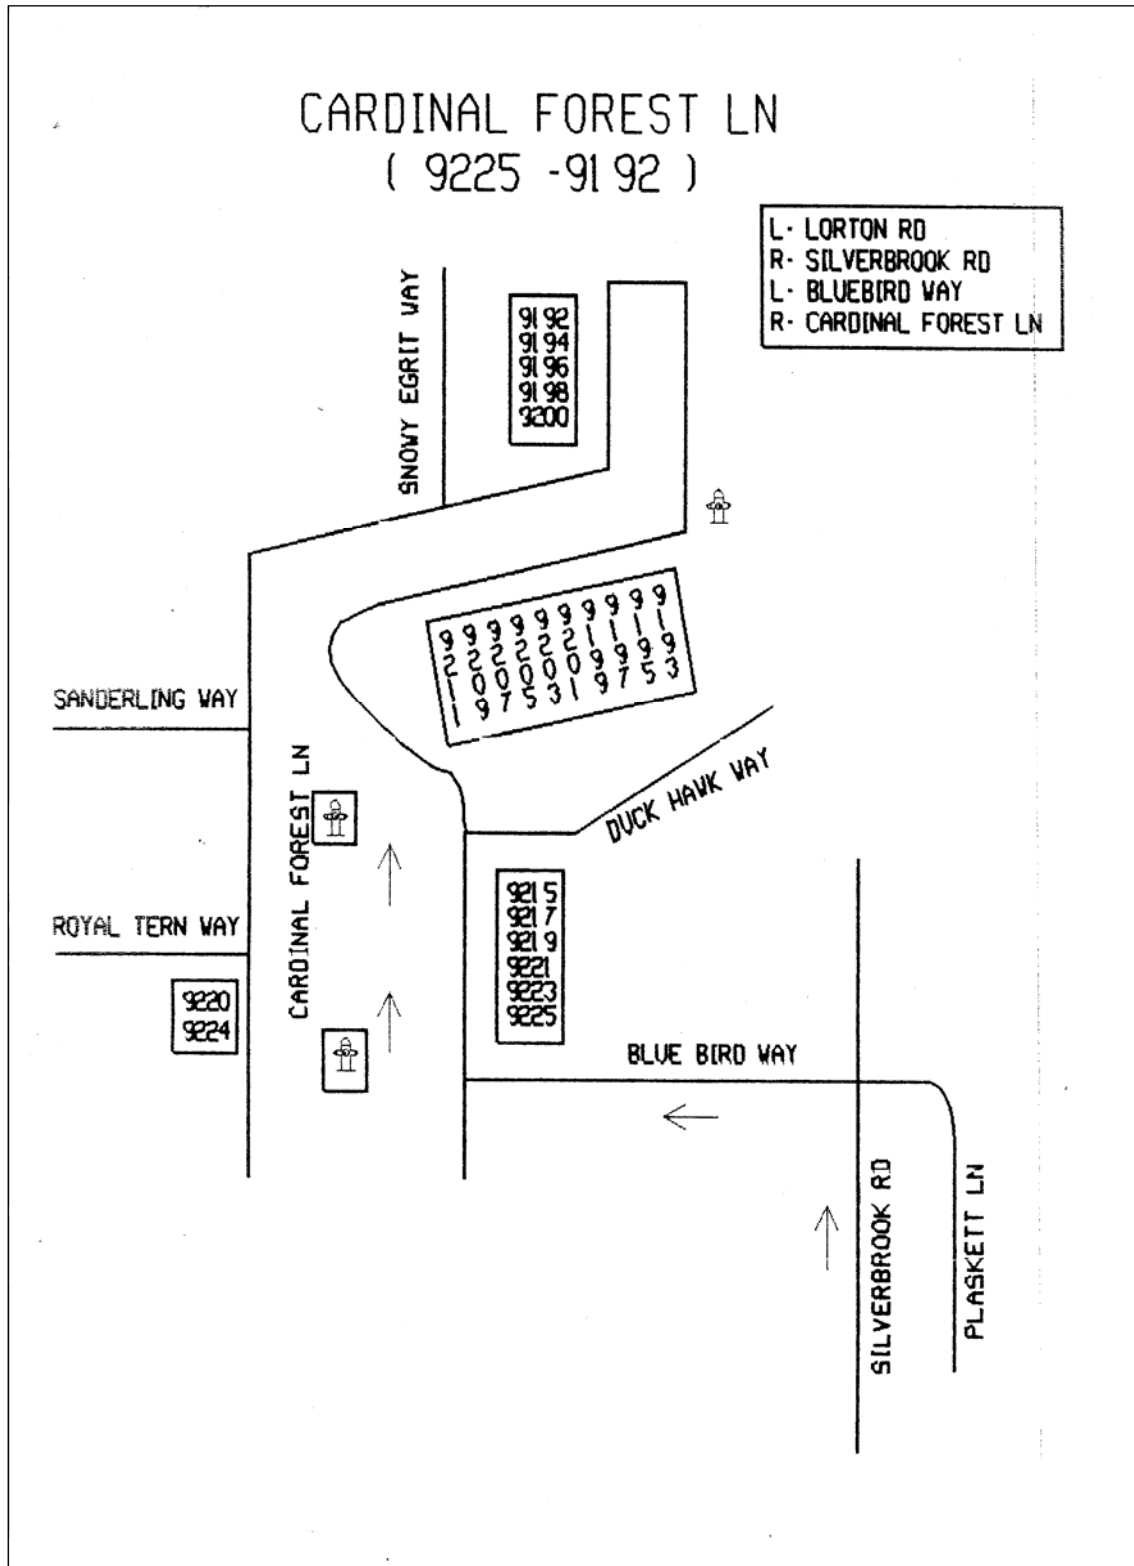
Attachment 1:
Engine 419's Response Map

1. The response map did not provide an accurate depiction of the address. Specifically, it did not indicate this address was part of a back-to-back style townhouse.
2. The first arriving engine selected and advanced an attack line that was too long. Additionally, the excess hose was not properly flaked out. These actions resulted in a delay in applying water to the fire due to kinks and a lack of pressure at the nozzle.
3. The first-due engine did not provide a situation report to include a command statement. Critical information such as the back-to-back townhouse feature, confirmation from an occupant of a person trapped, initial actions and assignments, command statement, etc. would have provided other responders with critical information and would have provided a foundation upon which to manage the incident.

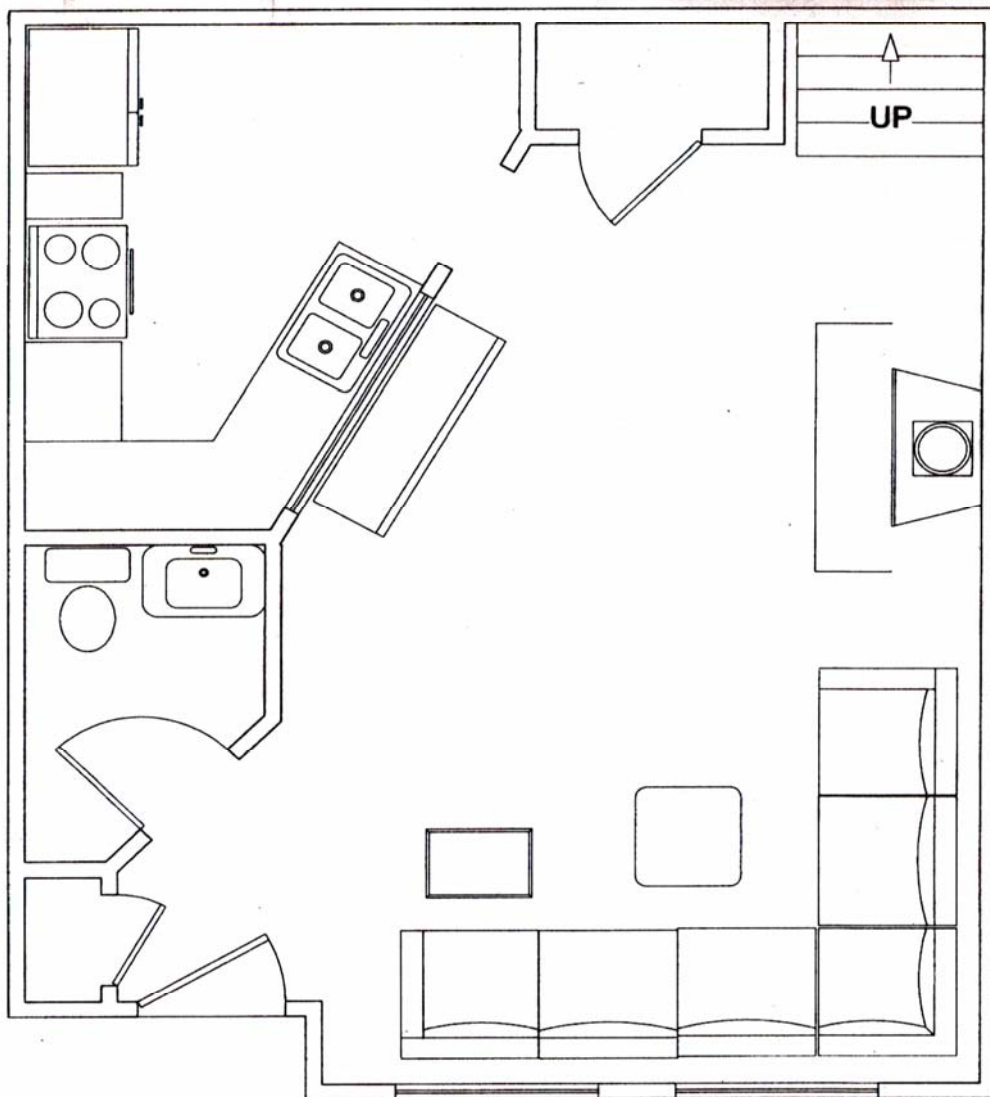
Attachment 4:
First-Floor Diagram

8. Crews inaccurately interpreted the fire conditions. R419 entered the front door with E419's crew, but then determined the conditions were too hazardous and the rescue crew withdrew; the engine crew was not withdrawn. Fire investigator's determined during their investigation of the incident that the fire was in the free-burning stage with relatively low heat above the first floor. Heat and smoke demarcation indicators were approximately three feet off the floor outside the first-floor kitchen area.

20071430093
9207 Cardinal Forest Ln.
Drawing Not to Scale
Side A - First Floor

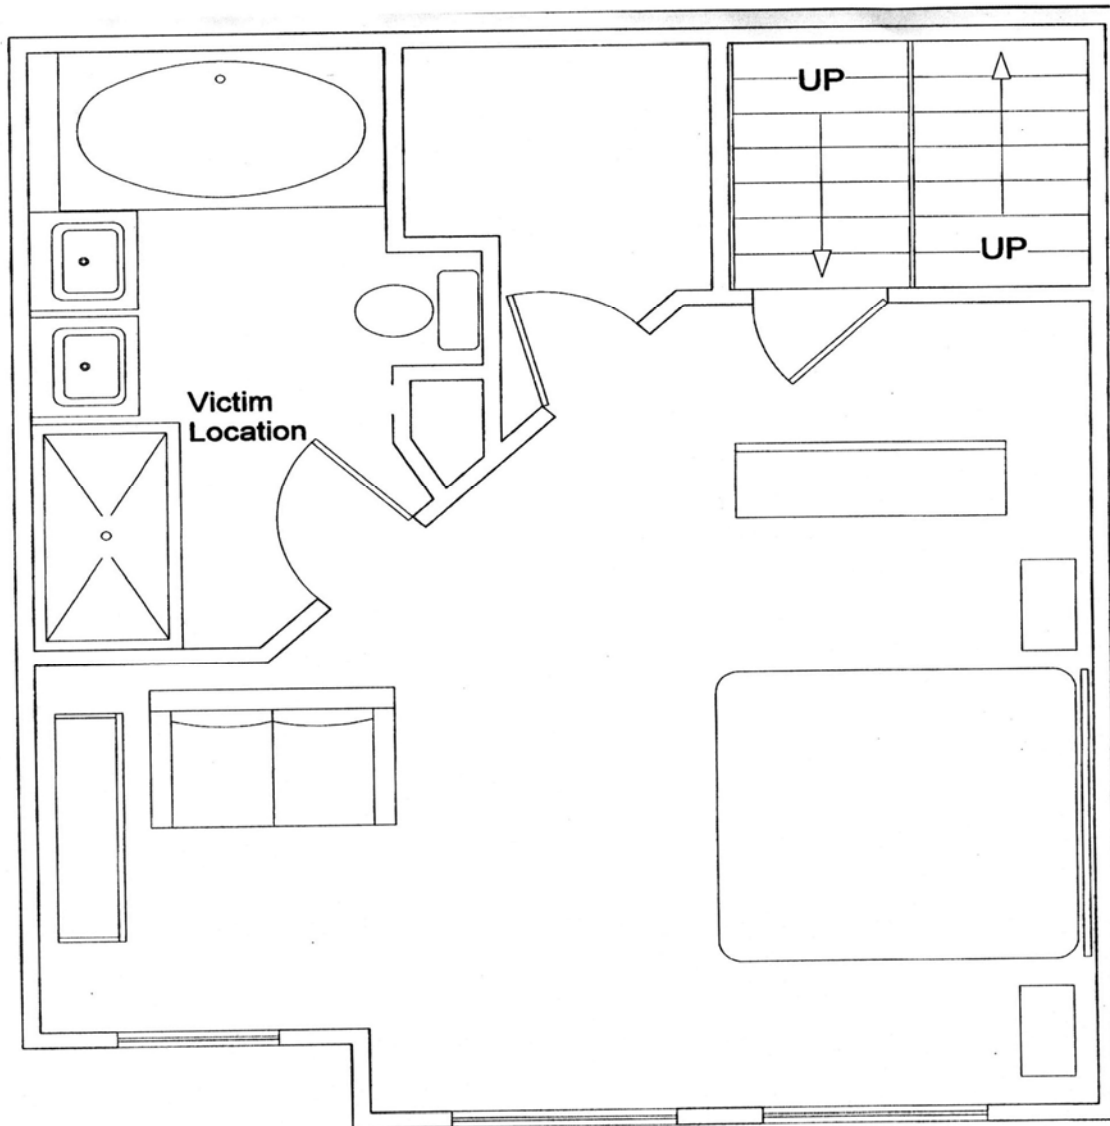
Attachment 6:
Third-Floor Diagram

7. Search efforts on the third floor were ineffective. The victim who died at this fire was found in a relatively small bathroom on the third floor. Despite statements from several personnel that they searched the bathroom--both physically and with thermal imagers--the victim was not located for over 40 minutes. The victim was located just inside the bathroom. There were no obstructions or obstacles to hinder locating her.

Side A - Third Floor
